Manhole Inspection Summary

Manhole # S17QQ1033MH

Insp Date: **11/15/06 7:45 AM**

Location Address: **5102 YELLOWWOOD AVE**

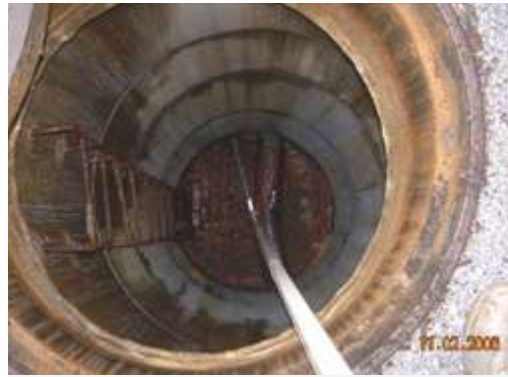
Top View

Corroded steps. Bench debris.

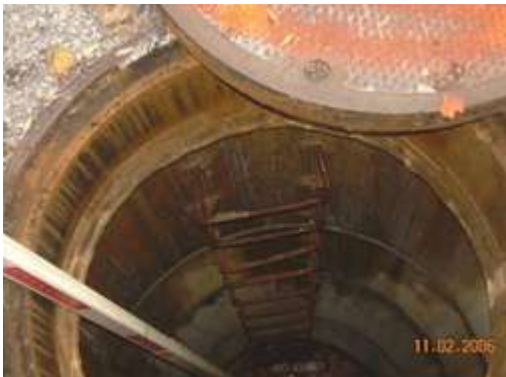
Defect

Frame leaks. Adjustment deterioration and infiltration. Corbel and Barrel infiltration. Corroded steps.

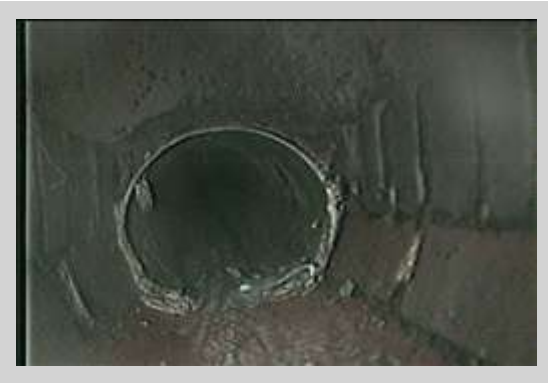
8 in. Circular Gravity Sewer Pipe Out @ 12 O'Clock

Channel deterioration.

Infiltration: **Evidence** Pipe Seal Cond: **Unknown**
